Sustainable Engineering Internship

2018 Final Report

July 15th, 2018

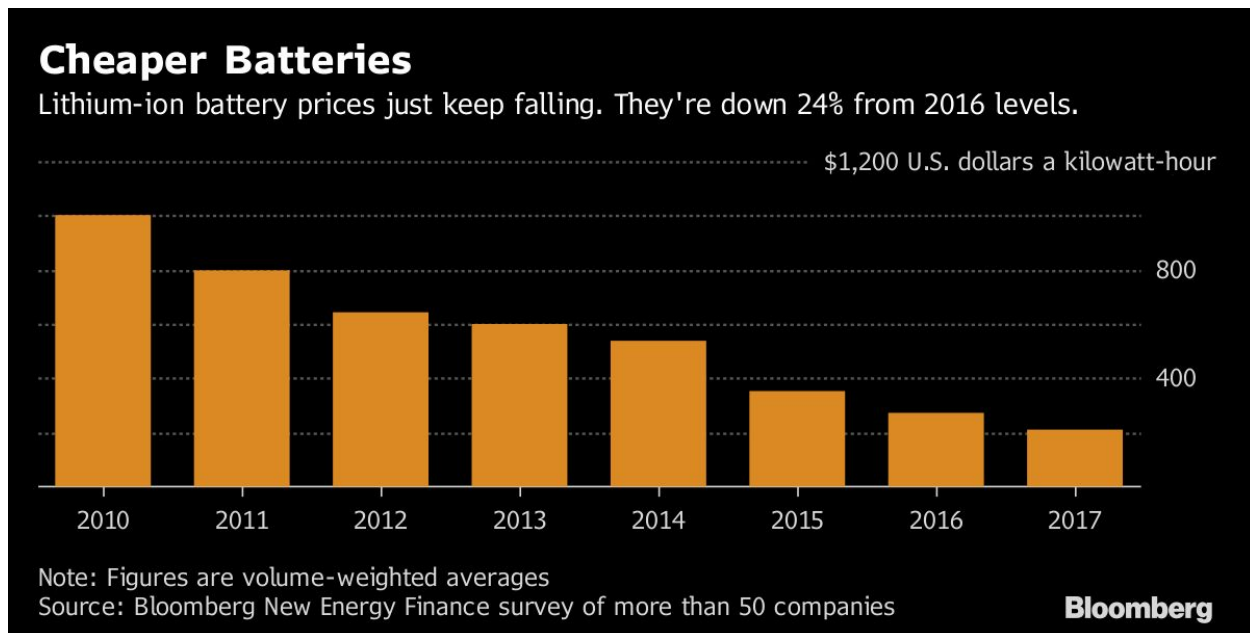
The current ECB lead acid batteries cost Shoals \$100,000; however, lithium ion batteries are also getting cheaper. The current cost for a kWh is \$209, and it is projected to get even cheaper, according to Bloomberg New Energy Finance Analyst, James Frith. The AGM batteries in the ECB is 300 kWh, which would be \$62,700 if they were replaced with Lithium Batteries. In the below chart, the smallest decrease in cost was 7%.

Figure 10: Decline in Cost of Lithium Ion Batteries. Graph from a Bloomberg New Energy Finance survey

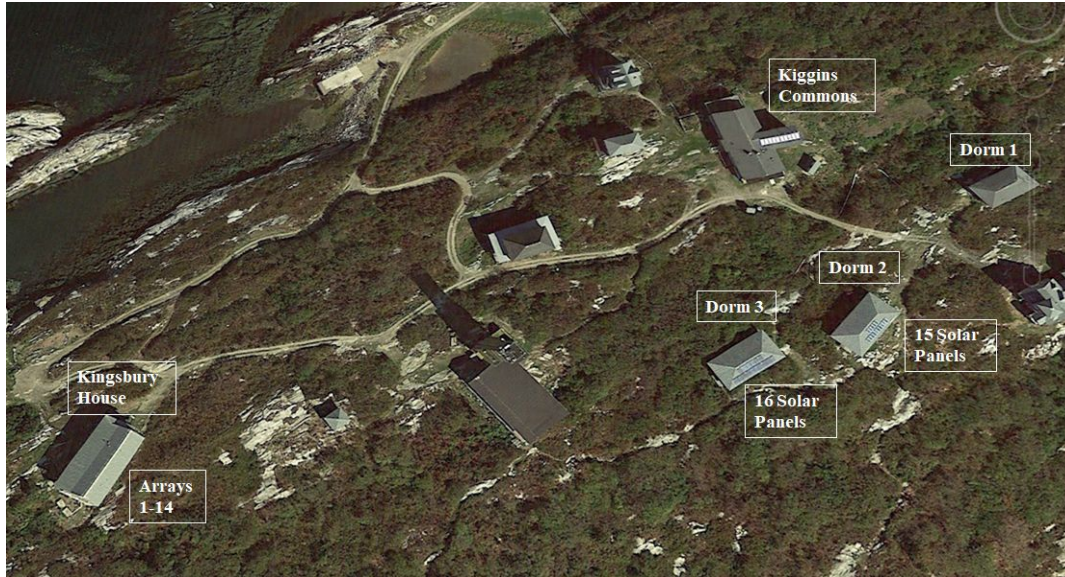
The arrays in the southern part of the island did not have the same ease of naming style, as the dorm panels are connected to the radar tower, and the Kingsbury House has its own system. The solar panels were counted on the dorms, and for K-House, the panels were identified the same way as the others. Each pair of the 14 arrays correspond to its own charge controller.

Figure 12: Layout of Southern Solar Arrays

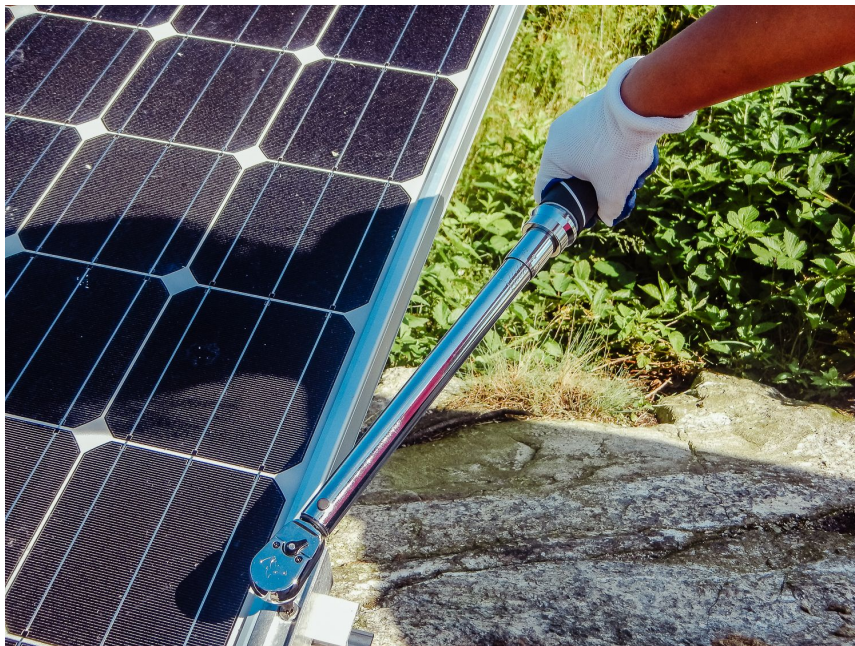
Another big part of maintenance is checking the bolts on the arrays and the wiring. The interns used a torque wrench to tighten the screws. Arrays 3-6 and 10-13 all had dry bolts which needed to be tightened to 10.5 foot-pounds. The torque wrench was calibrated to this exact value, and automatically clicked when the 10.5 ft-lb force was reached. The ground arrays were the only arrays where the bolts were tightened, since there is not as safe a footing on the roof arrays. Arrays 10-13 are higher up than arrays 3-6, so the interns used a ladder; however, the interns were unable to reach the second row from the top of the ground arrays past the pole barn.

Figure 13: Tightening Bolts

The ground arrays' conditions haven't been checked since 2014 installation. A torque wrench was used to tighten the dry bolts on the ground arrays. Most of the bolts on the arrays by the ECB needed a few turns to tighten, which was looser than expected. A ladder was utilized to reach the higher bolts. The bolts on the ground mount arrays past the pole barn needed much less tightening. Although many were at the recommended torque value to begin with, there were also

some bolts that needed tightening. The distribution between tight and loose bolts was random, so the interns checked all the bolts that they could safely reach. This loosening was probably caused by vibration caused by wind and by tightening the dry bolts, it helps lessen the friction between parts that might reduce efficiency.

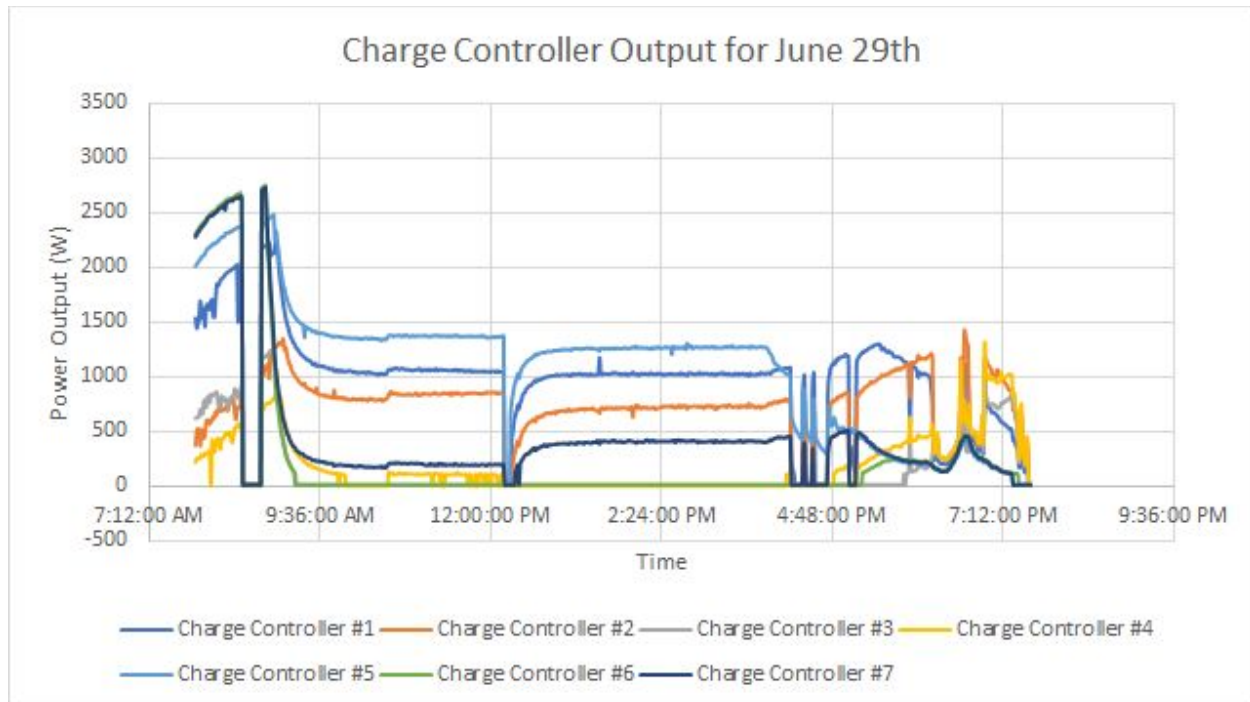
Figure 16: Graph for each Charge Controller of K-House for June 29th

The interns took these measurements on June 29th at around 11:30 for K-House. At this point, charge controller #6 is producing 0W; however at about 8am it was producing the most wattage. This means the orientation of charge controller #6 is most efficient in the early morning, and not when the interns measured it. Charge controllers 1, 2, 3 and 4 are connected to solar panels on the NW, with 4 connected to panels at a lower angle. They generally perform best in the late afternoon and early evening. Charge controllers 5, 6 and 7 are connected to solar panels on the roof facing SE, and perform best early in the morning. This is exactly the intention of installation in the first place, trying to spread out the peak performance time throughout the day.

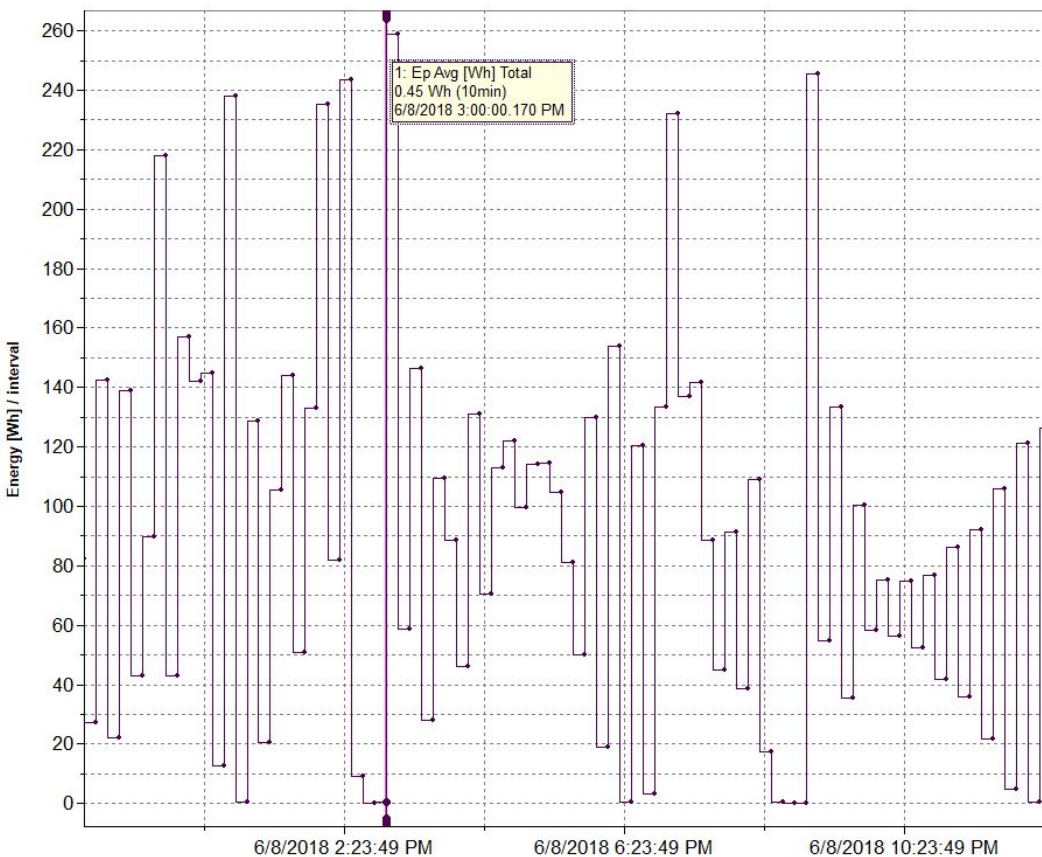
Figure 18: Graph of Energy Consumption of the Fridge Compressor over several Hours

Justin Ulrich from Unitil came to help the interns understand the fridge data. He said the since the data was varied, characterized by the significant variance in figure 18, it meant the power coming in from the generator was not in phase with the compressor motor. A variable frequency device (VFD) can be used to correct for this.

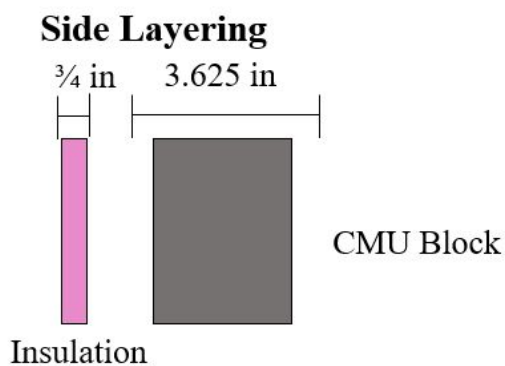
The insulation is a two part urethane foam, which surrounds the system. On the top side, there is insulation, a plastic layer, and a piece of plywood. The left and right sides have insulation and a concrete masonry unit (CMU). The back is just a large CMU. The front side is a metal door, and CMUs.

Figure 23: A Layout of the Top Wall

Figure 24: A Layout of the Back Wall

Figure 25: A Layout of the Side Walls

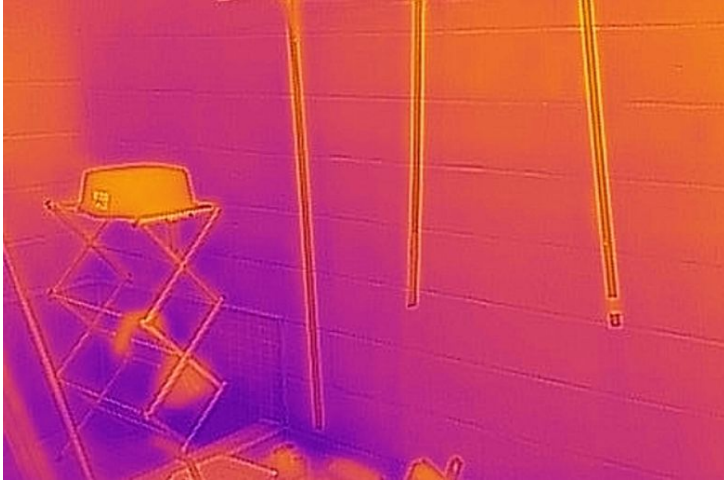
The fridge and freezer on the walls represent the distinction between where the fridge ends and the freezer starts. Tom Johnson lended interns a thermal imaging device to show the temperature gradient on the outside wall of the fridge and freezer. Dark purple represents lower temperature heat seepage from the freezer.

Figure 26: Infrared Picture of Left Outside Wall of System

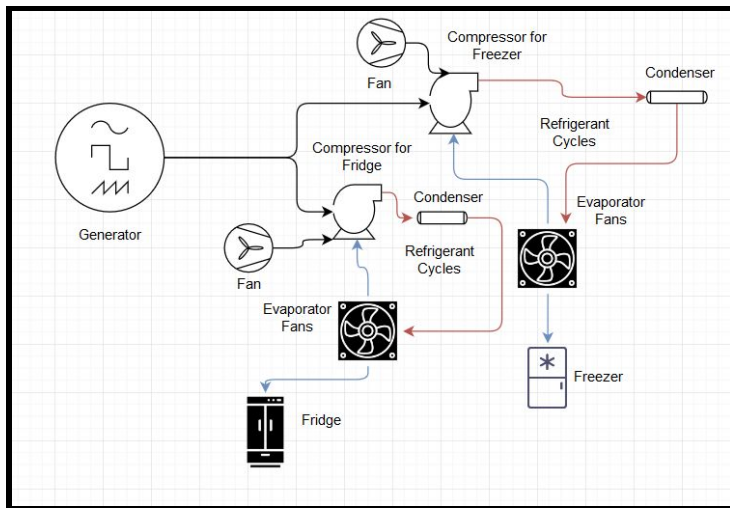
Figure 28: Representation of how the Refrigerator System Operates

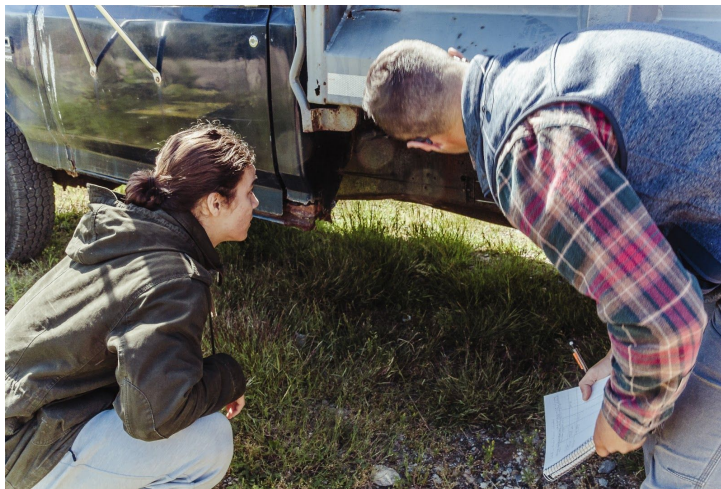
1996 Ford F-350 Powerstroke Diesel Dump Truck:

Figure 35: Heavy rusting on the underbody

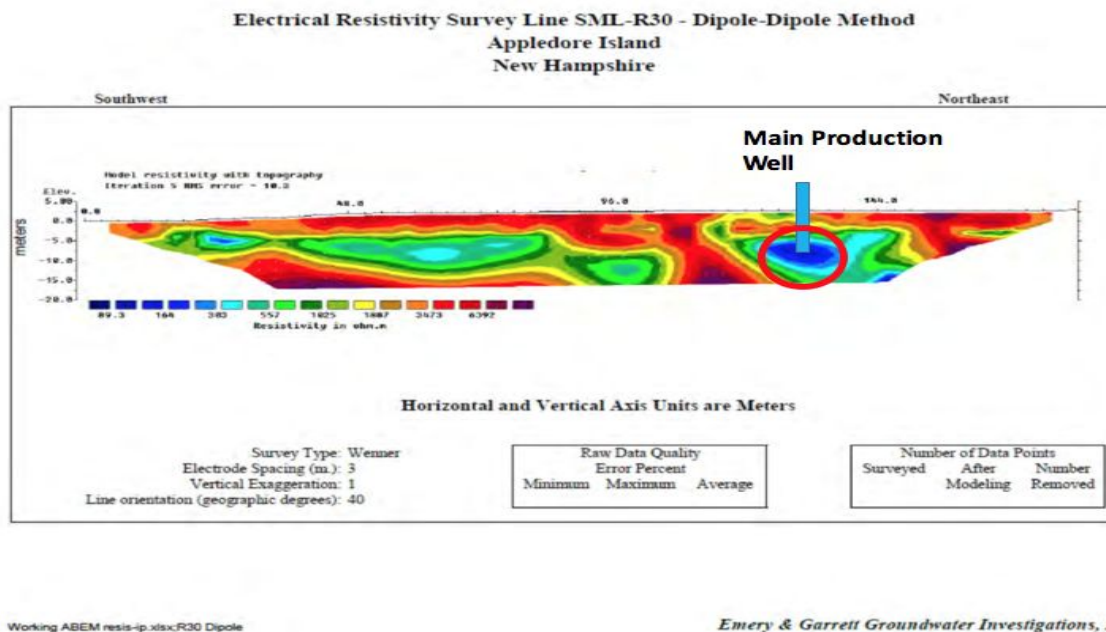
In 2016 SEI report, the interns partnered with EGGI and conducted an electro-resistivity survey. The resulted ER imaging is shown below.

Figure 41. The Electrical Resistivity Imaging of the Main Well and the 6-foot Test Well
