# Sustainable Engineering Internship 2022

## Final Report

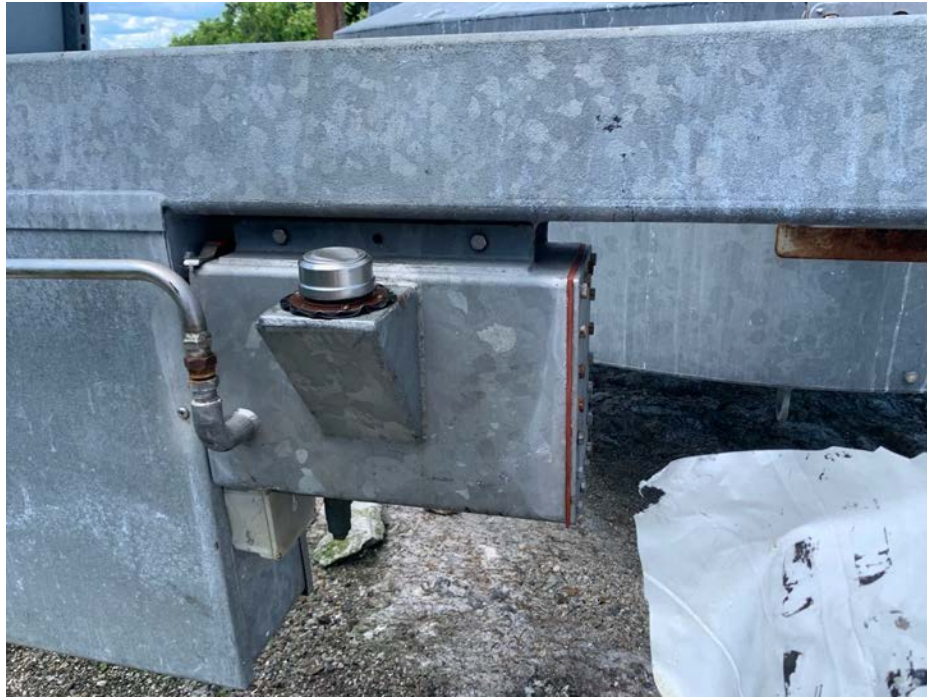
Figure 1.3: Hydraulic reservoir tank. The right side is a separate sheet of metal bolted to the rest of the tank and fitted with a gasket.

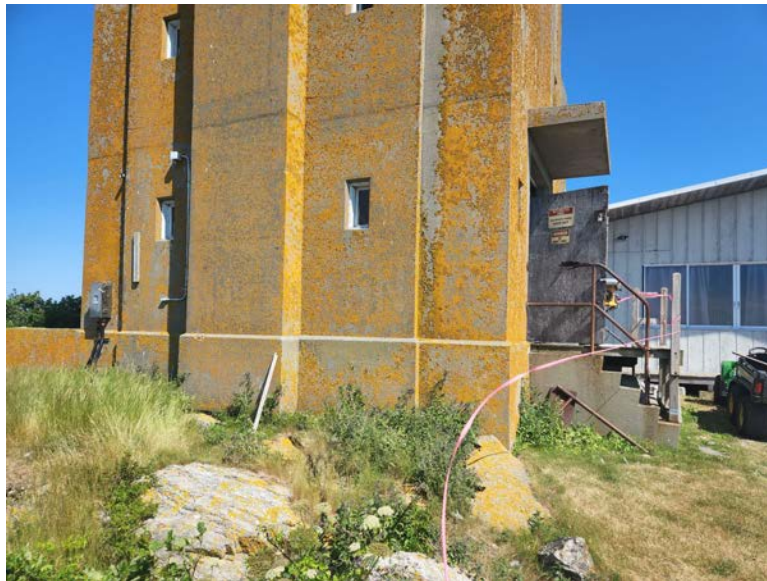
Figure 2.1: Ledge of Radar tower as measured for future studies, even with top of exterior stairs and base of door.

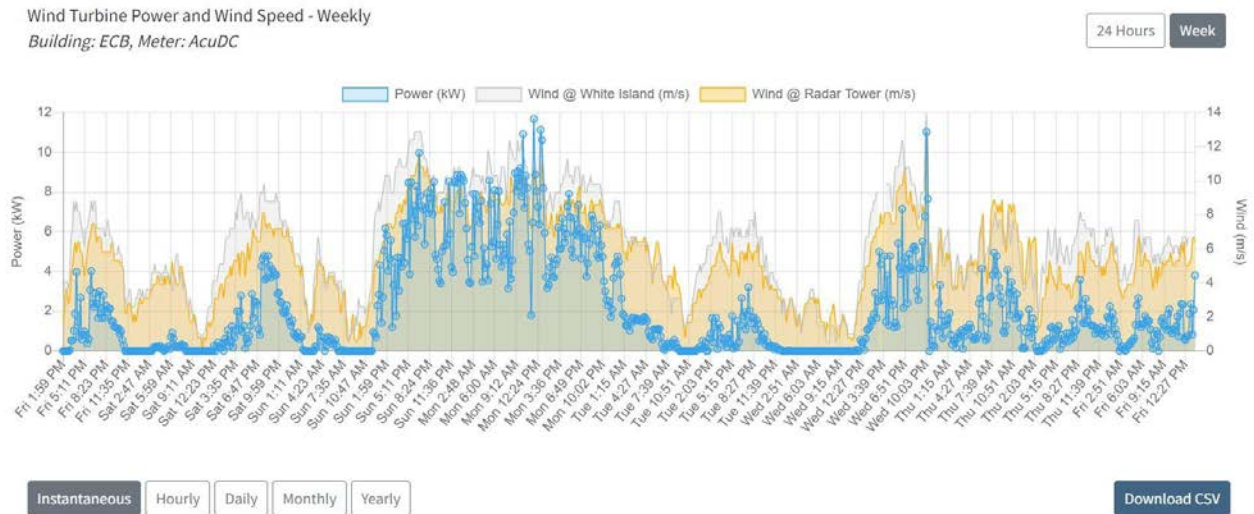
Figure 2.3: Example Shoals dashboard wind data for Friday June 24th 2022 through Friday July 1st 2022. The White Island wind speed, in white, is generally faster than the Radar Tower wind speed, in orange. The power output is also shown.

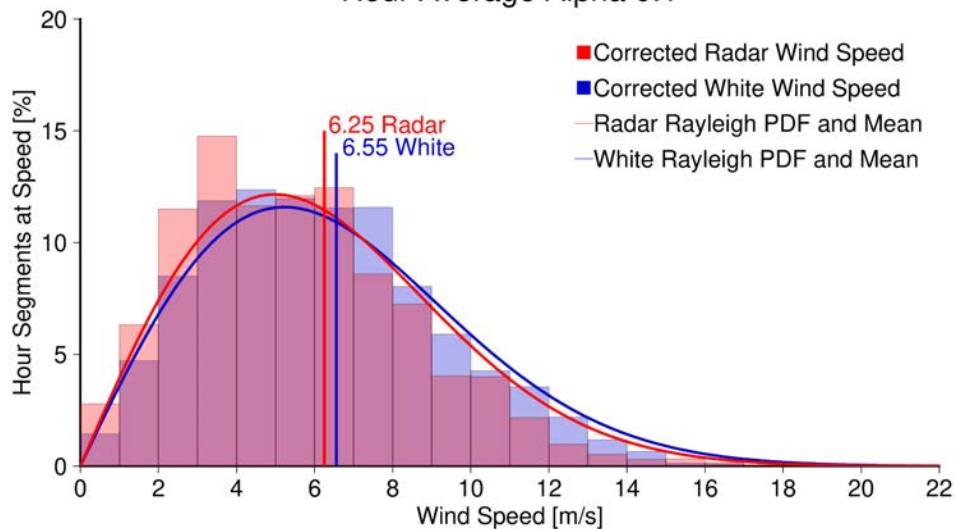
### Normalized Corrected Wind Speed At 36.4 Meters AMSL Hour Average Alpha 0.1

Figure 2.4 Alpha = 0.1 corrected wind speeds normalized histogram for June 19 2021 - June 23 2022 of both White Island and Radar Tower anemometer readings, with a fitted Rayleigh probability density function (PDF).

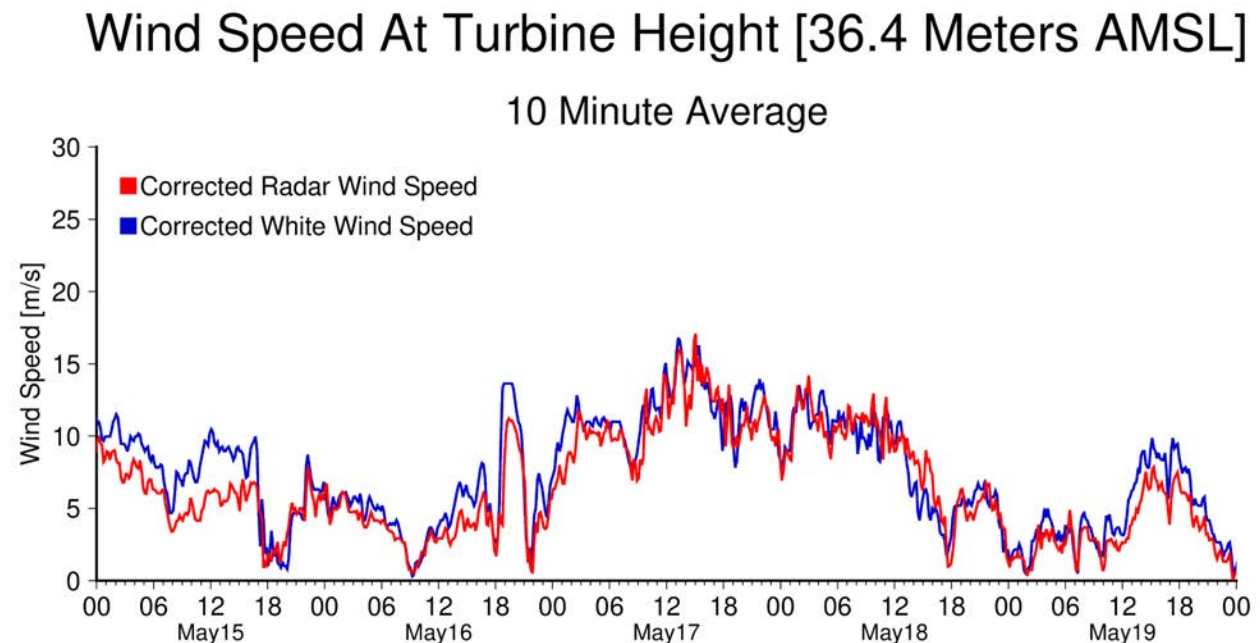
Figure 2.5: Five-day example time series of 10 minute averages of the White Island and Radar Tower wind speeds corrected to turbine height during a range of wind conditions. The White Island wind speed is typically higher, but the two readings closely follow each other.

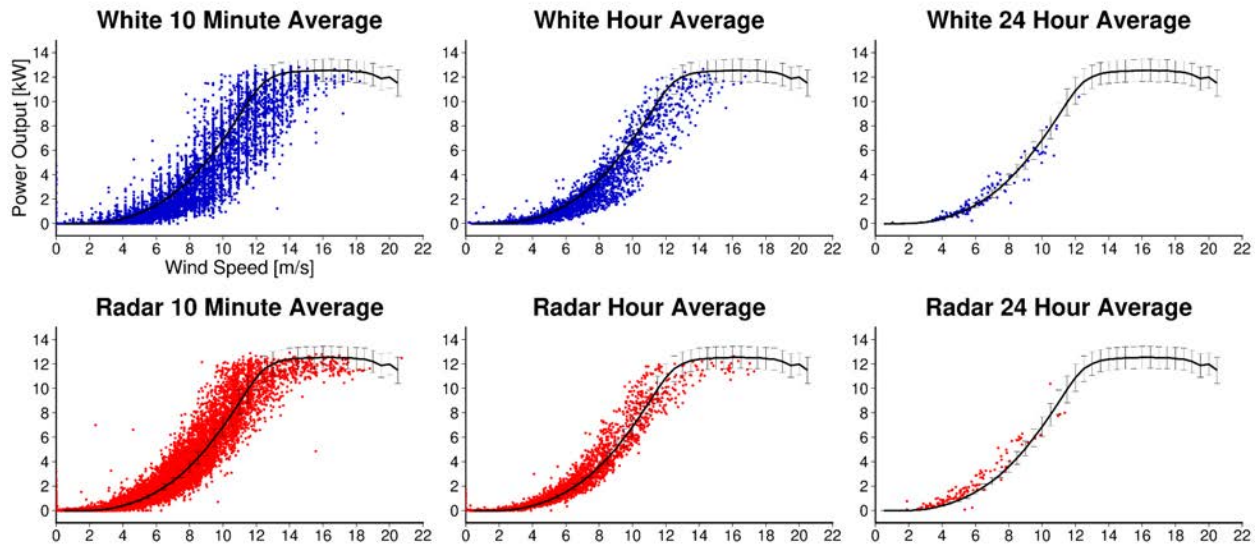
## Manufacturer Versus Actual Power Output

Figure 2.7: Power output versus wind speed. Bergey summary report findings from a 9-month field test are shown as black line with combined error bars. Each scatterpoint represents a 10 minute, 1 hour, or 24 hour averaging of wind speed and output power. The White Island 10 minute plot still has remnants of discretized wind speed readings. As averaging time increases, the data more closely matches what is expected from the summary report. An abundance of nonzero power output points at zero wind speed for the Radar Tower are due to lack of wind speed data at the Radar Tower for that time period. The White Island data falls on and slightly below the summary report curve, while the Radar Tower data falls on and slightly above the summary report curve, as expected for faster wind speeds recorded at White Island. Based on the averaging, the turbine is performing as expected. Lack of extended high speed events make analysis of the upper portion of the curve difficult, but it qualitatively looks to be at or slightly below as expected by the summary report.

Bergey publishes a summary report that shows the results of the turbine power output testing, including a table of hub height wind speed versus expected power output, with combined standard uncertainty. Because measurements of wind speed by both the Radar Tower and White Island anemometers are discretized, plotting individual data points results in unhelpful lines showing what wind speeds are measured by each anemometer. White Island reports wind speed every 10 minutes and the Radar Tower reports wind speed every minute. Thus, 10 minute, 1 hour, and 24 hour averages were considered. A scatterplot comparing the different averagings to the summary report results is shown below (Figure 2.7).

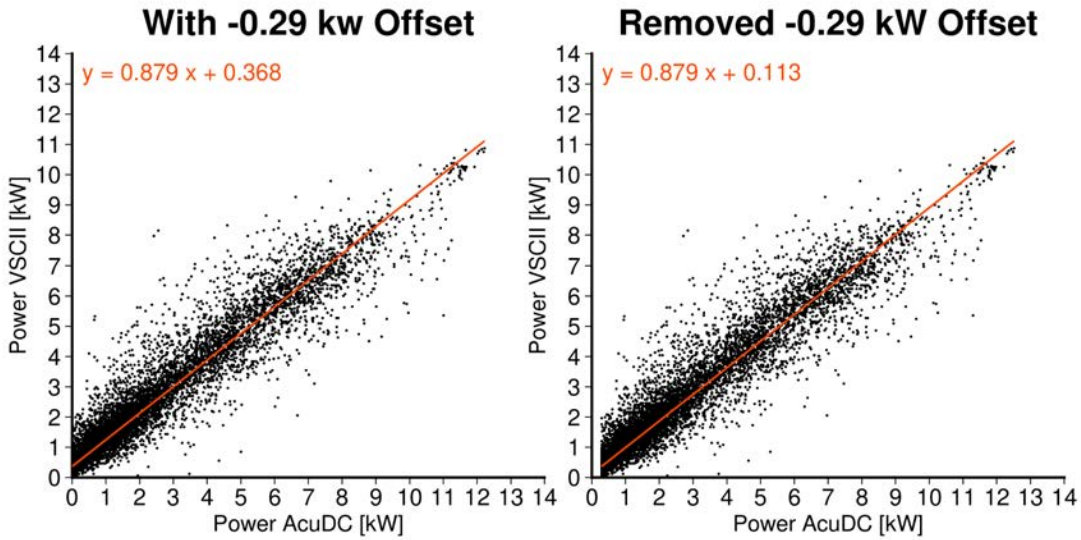
Figure 2.8: VSCII power output versus AcuDC power. Linear regression shows fairly strong correlation between the two ( $R^2 = 0.9237$  in both plots). Slope less than one signifies that AcuDC is slightly greater on average.

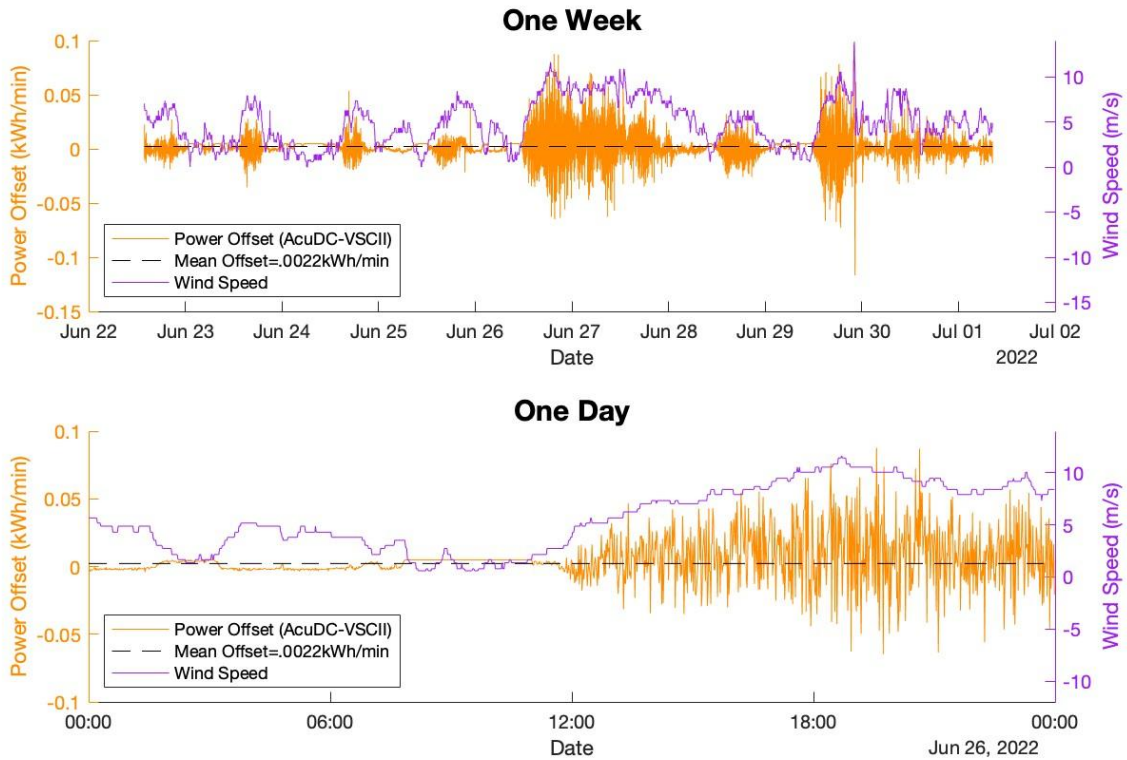
Figure 2.9: Power offset and wind speed over time. Data is plotted every minute. The top graph is over the course of a week. The bottom graph is over one day. Peaks of offset seem to occur when there's peaks in wind speed. The mean power offset is .002 kWh/min, meaning AcuDC is slightly greater than VCSII readings on average.

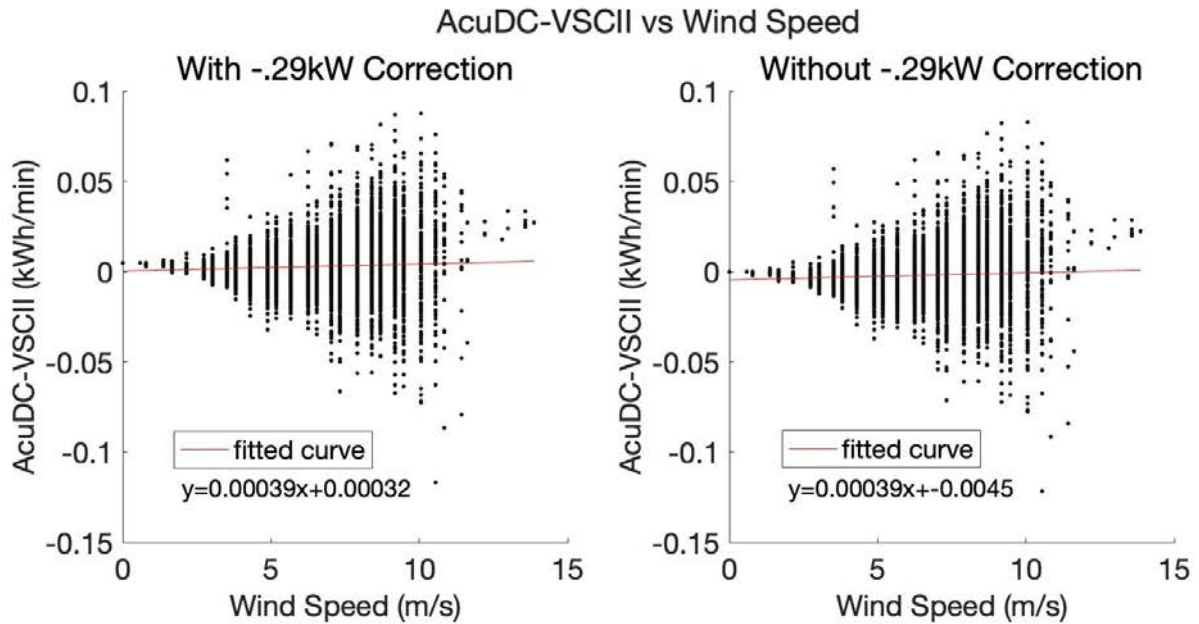
Figure 2.10: Power offset versus wind speed. Positive slope shows that at higher wind speeds offset is slightly higher. Range of offset values increases with wind speed, but there can still be no offset at high wind speeds.

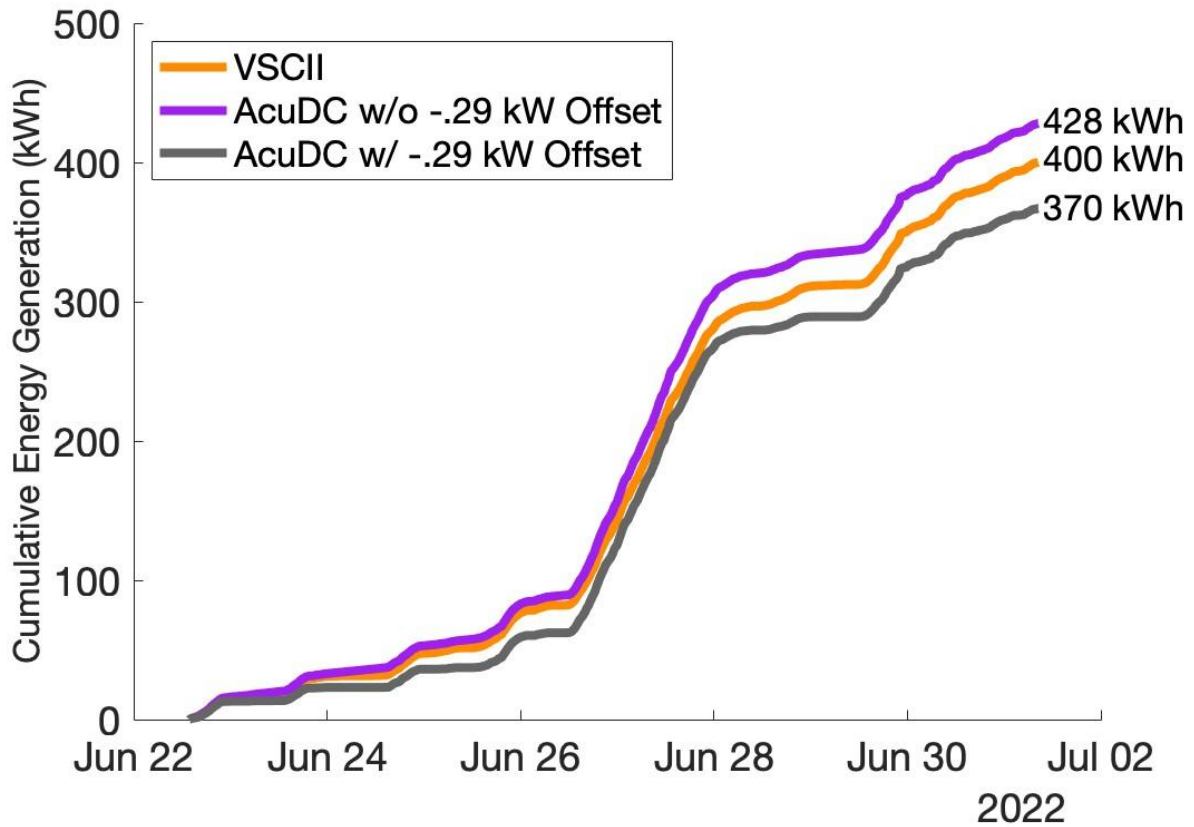
Figure 2.11: Cumulative energy generation over the course of a week of VSCII and AcuDC, with and without the -.29 kW correction. AcuDC raw data overestimates energy generated, while the Dashboard underestimates how much energy generated..

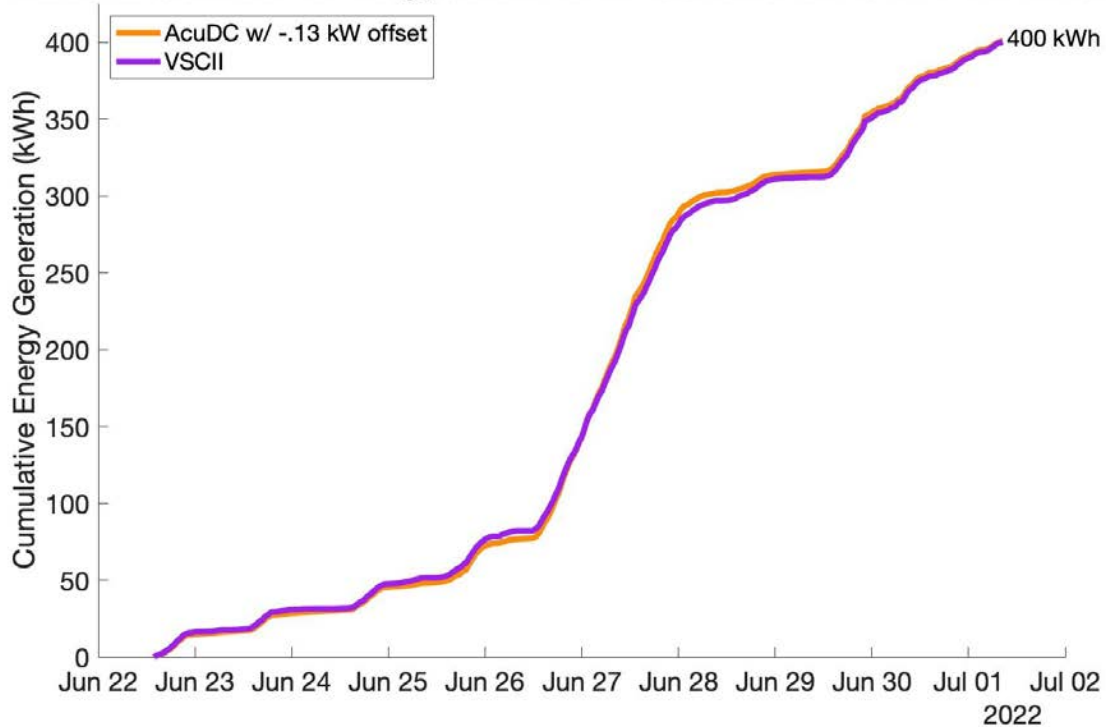
Figure 2.12: Actual energy generated over the week from VSCII and the AcuDC energy generated with recommended -.13 kW correction. At the end of the week, both sets of data total the same amount of energy generated

If, however, future research is determined not to be worth pursuing, then the interns recommend an offset of  $-0.13\text{kW}$  be applied to AcuDC data to be displayed on the dashboard. While this offset might not display the exact instantaneous power output of the turbine accurately at any given moment, the goal would be to have an accurate measurement of total energy generated over a period of time. With this offset, the total energy generated over the week we measured came out to the same value. Hopefully, this offset would make values of energy generation over a month or a year match up as well. This offset also coincides with the  $0.125\text{kW}$  value the interns observed displayed on the AcuDC when the VSCII was turned off. This offset should provide more accurate data that is indicative of how the island is performing in terms of sustainability, i.e. how much green energy is generated over the course of a season.

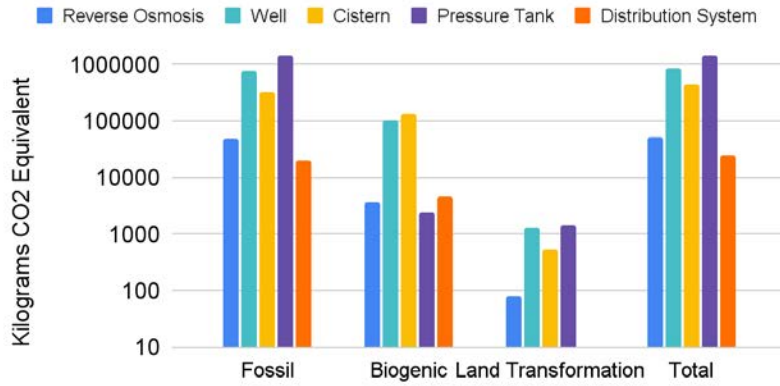
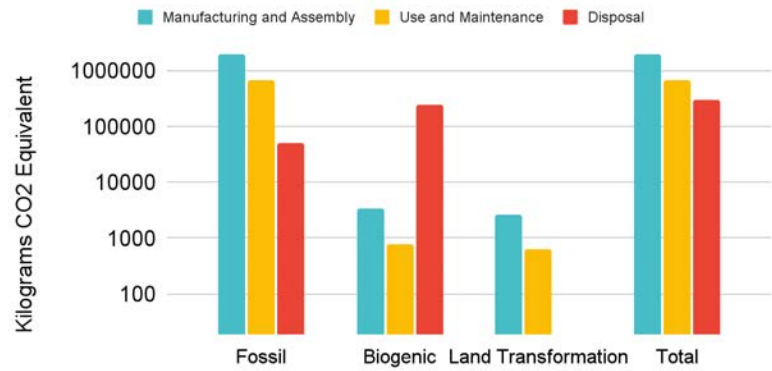
Figure 3.4: Fossil, biogenic, land transformation, and total emissions for a 100 year life cycle analysis of SML’s drinking water system, by system component (left) and life cycle stage (right). Fossil emissions are typically the largest component of emissions over any component and life cycle stage. Total emissions from the well and pressure tank are largest, due to the large amount of metal used in their construction; this also inflates the manufacturing and assembly emissions. A small use and maintenance emissions means that as the system continues to operate for longer, it becomes more sustainable

It was found that the life cycle of the freshwater system would release the carbon dioxide equivalent of 2935872 kg into the atmosphere. The stainless steel pressure tank resulted in the largest overall carbon dioxide equivalent production due to the emissions from fossil fuels in the manufacturing phase of the life cycle analysis. The tin for the well, another metal component, largely contributed to the equivalent carbon dioxide emissions.

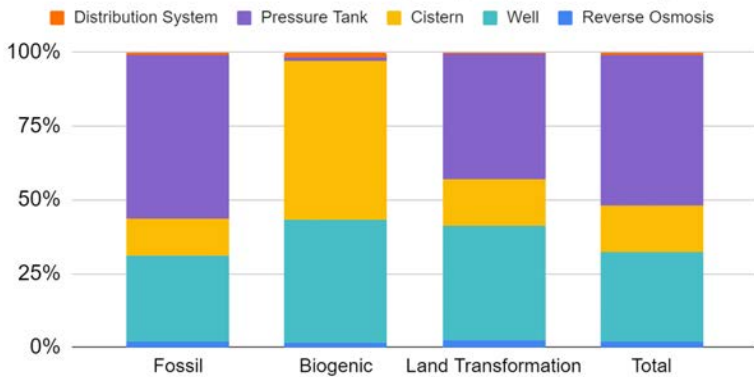
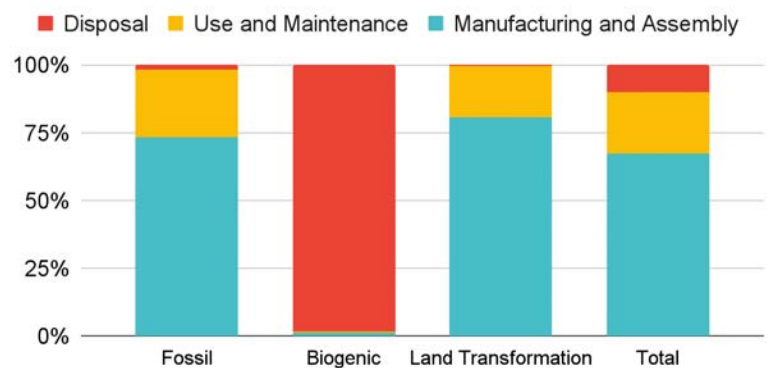
Figure 3.5: Fossil, biogenic, land transformation, and total emissions percentages for a 100 year life cycle analysis of SML’s drinking water. Total emission percentages from the well and pressure tank are largest, due to the large amount of metal used in their construction, but the cistern has a large biogenic impact. Disposal produces most of the biogenic emissions, due to organisms in the landfill.

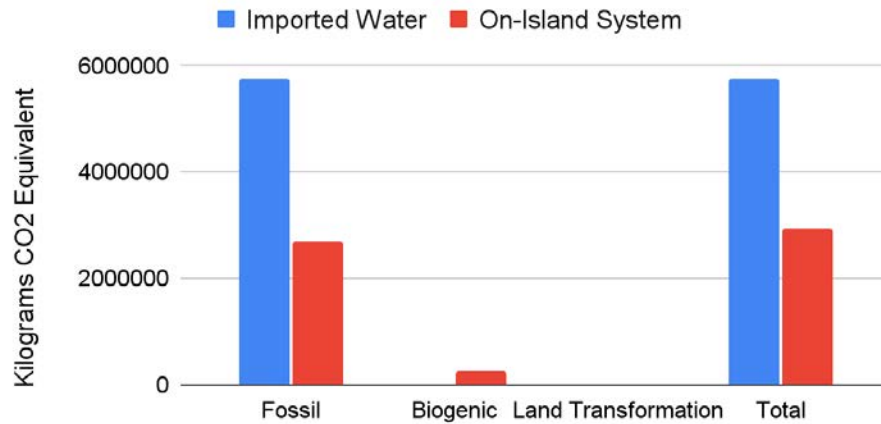
Figure 3.6: A comparison between the current freshwater drinking system and importing water shows importing has almost twice the emissions over a 100 year time span. Because most of the emissions of imported water come from the use phase, boating it over to SML, compared to the manufacturing phase in the current system, the imported water system becomes worse the longer it is used.

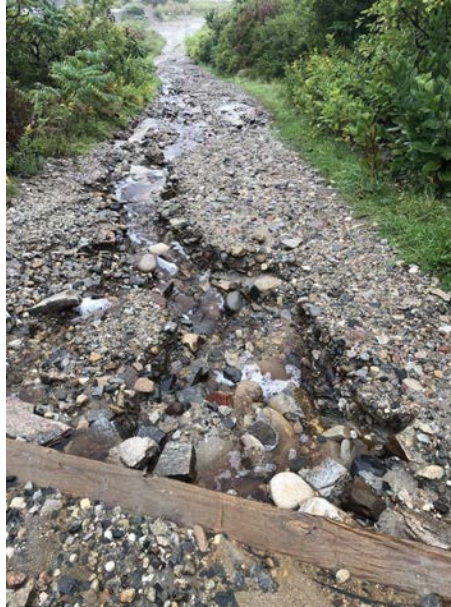
Figure 4.1: Erosion after storm surge

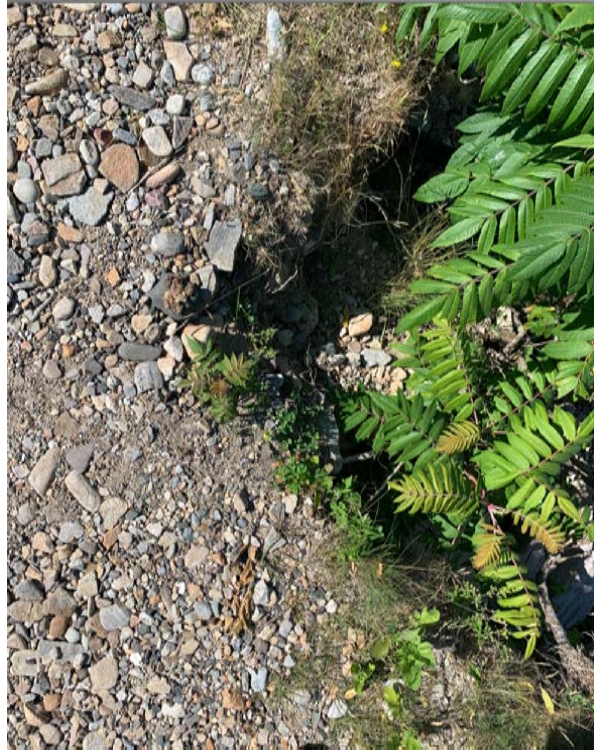
Figure 4.2: Erosion caused by winter storm damage

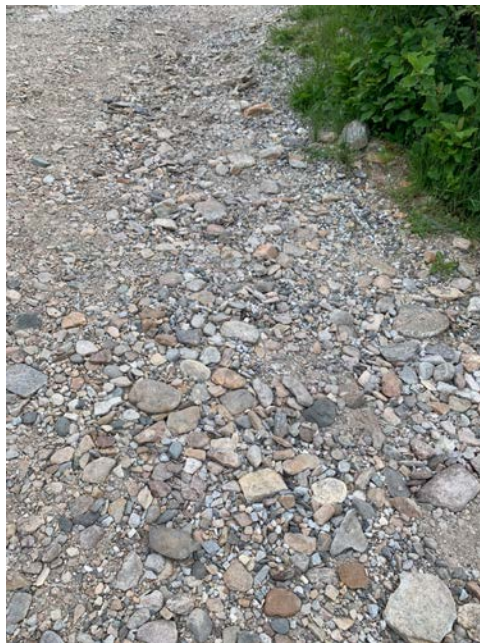
Figure 4.3: An eroded area of road

The roads are filled with finer gravel material that becomes washed out with water flow during a storm. When walking along the roads, evidence of erosion is present where there is larger aggregate, as the finer material has been removed by water flow, shown below in Figure 4.3.

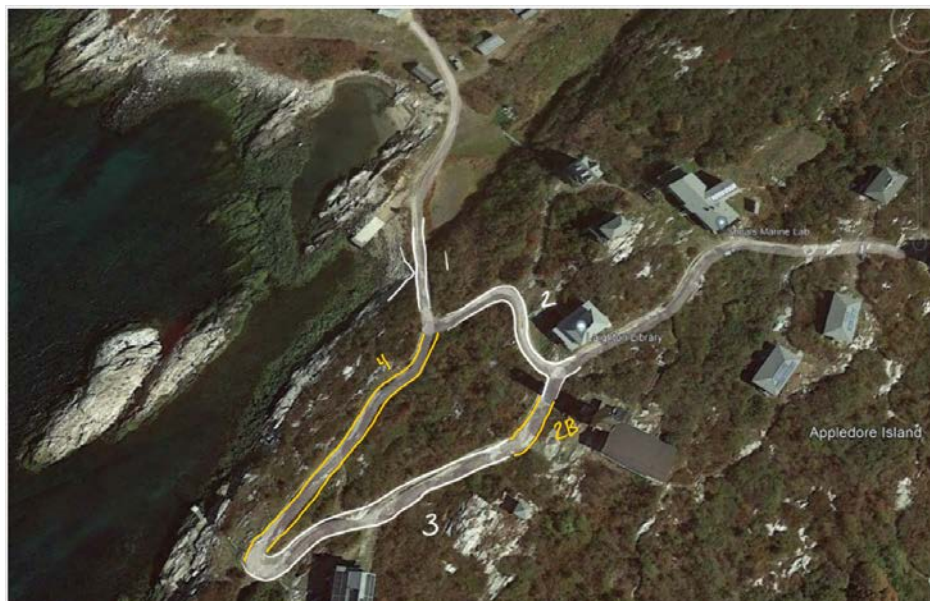
Figure 4.4: Erosion sites, Appledore Island 2022

The loop shown in Figure 4.4 was studied in five different sites of the steepest slopes of the island roads. Site 2B is on the same slope of Site 2, but due to the turn in between sites, it was split into two sections.

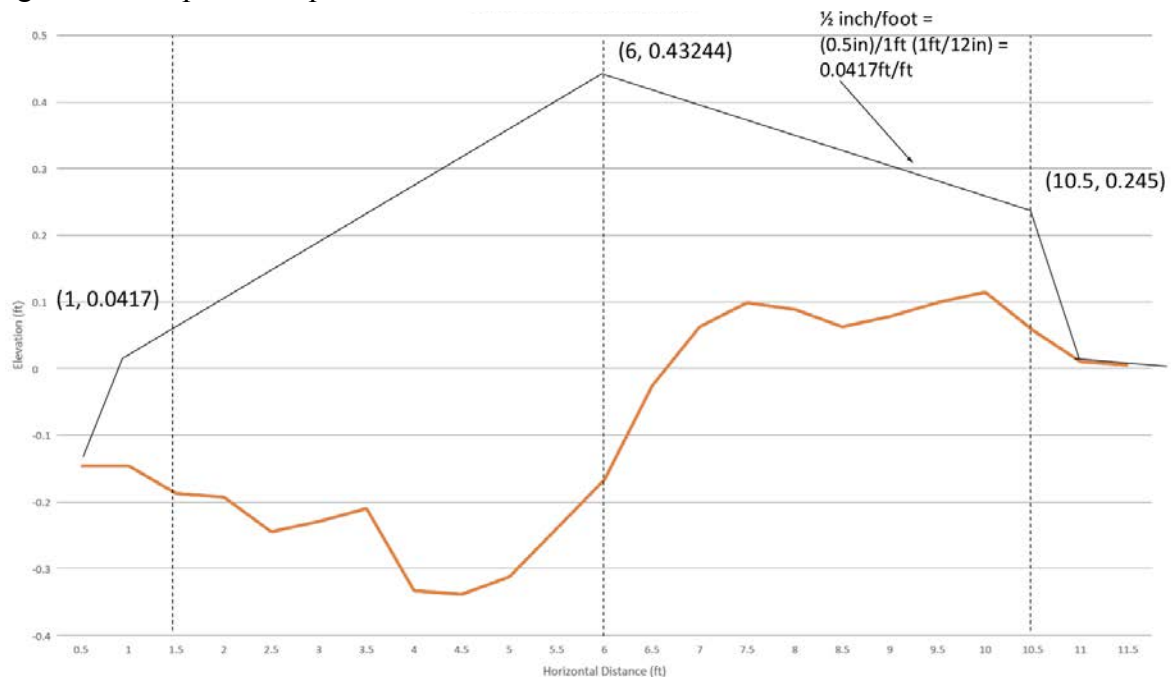
Figure 4.5: Site 1 Horizontal Profile

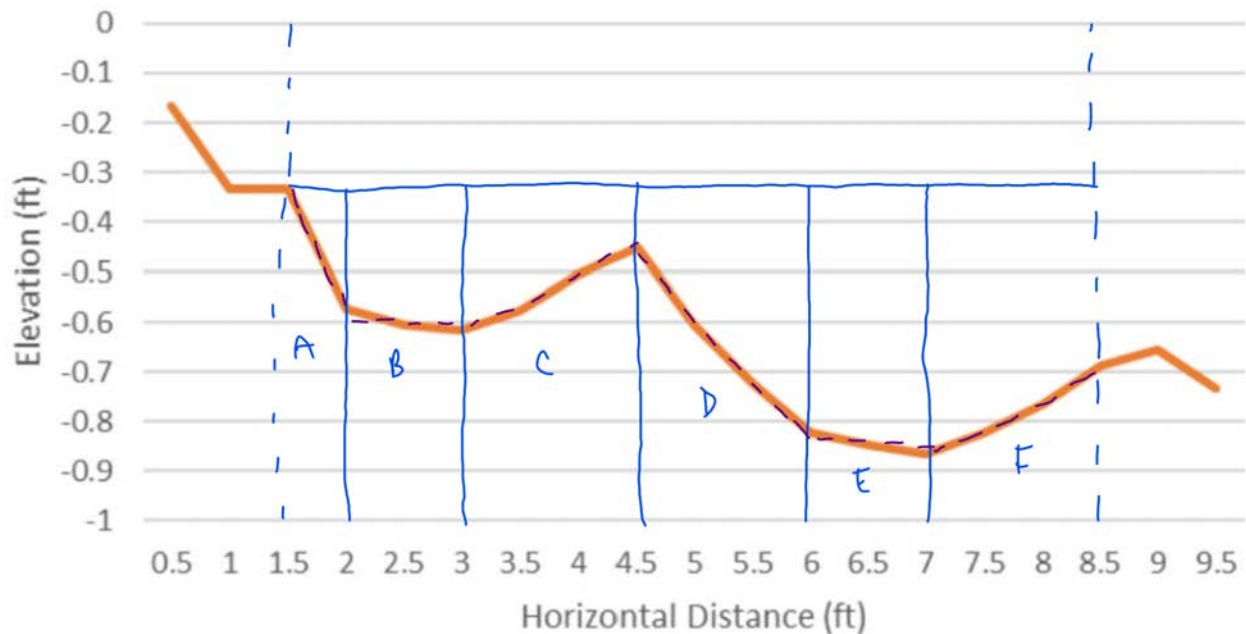
Figure 4.6: Flat Fill Site 2B

To calculate the minimum amount of fill needed to return the roads to a good condition, a line from the highest elevation of the horizontal profile (excluding the edges of the road) was drawn across the profile for each site. Figure 4.6 shows that the profile was then divided into sections of similar shapes in order to approximate the area between the existing elevations and the horizontal line drawn across. The areas of these sections (Table 4.1) were then added together and multiplied by the minimum distance that should be filled. The minimum distance was determined by the interns in the field, measuring the lengths of the areas with the worst conditions. This would allow the interns to analyze how much fill would be needed if the island staff wish to fill in the more dire areas, as opposed to creating a crown along the whole slope.

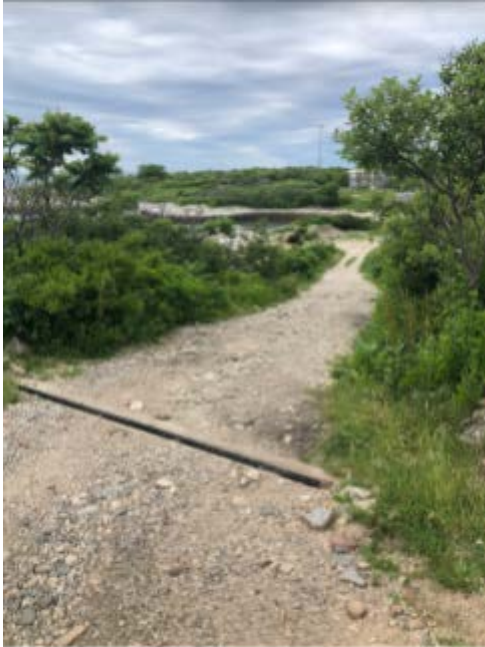
Figure 4.8: Culvert on coastal slope on the western side of the island 6/16/2022

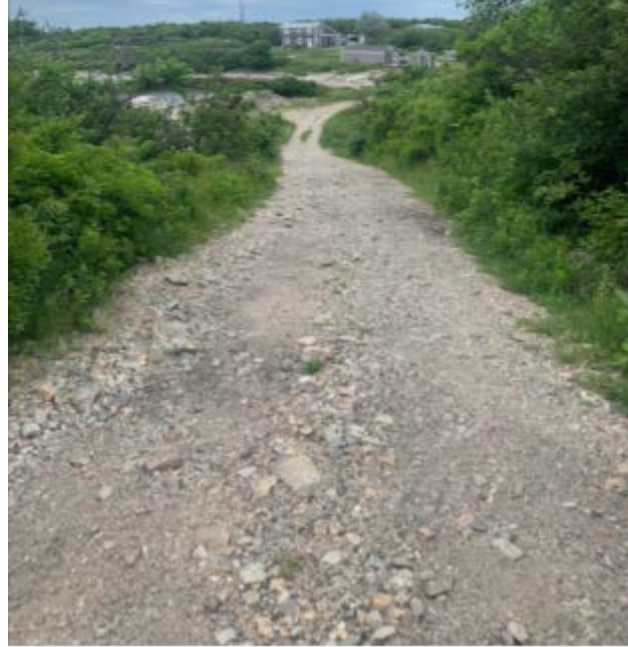
Figure 4.9: Below culvert on coastal slope on western side of island, 6/16/2022

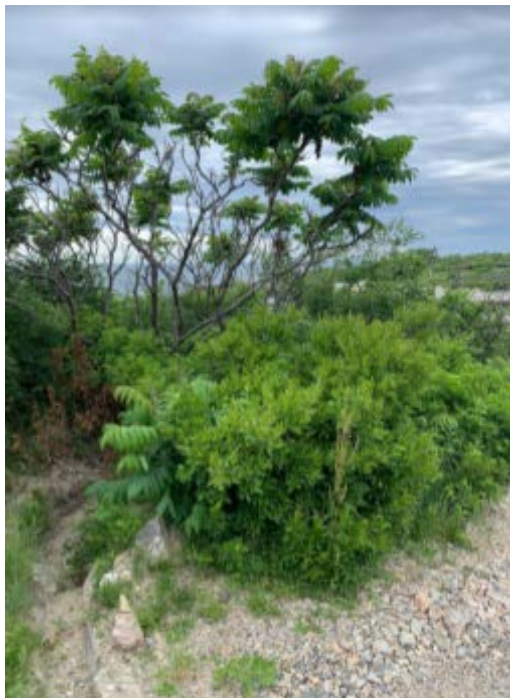
Figure 4.10: Vegetation on coastal side of slope on site 1, 6/16/2022

There is thick vegetation on the coastal (western) side of this site, which mostly protects the road from erosion, besides the area carved by a previous storm. This vegetation includes grasses, bushes, and small trees, as seen in Figure 4.10. The inland side of this site also has similar vegetation and is much thicker.

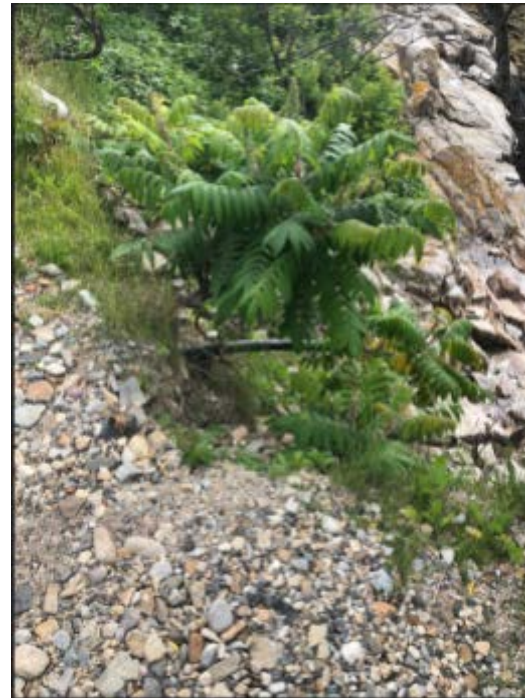
Figure 4.11: Pipe protruding from hillside at severe coastal erosion site 6/16/2022.

Since there is the aforementioned area of severe erosion, the interns believe that the road must be shifted inland by approximately two feet, which would involve cutting and removing some of the thick vegetation. In addition, because this site is closest to the coast and most vulnerable to coastal erosion, a soft or hard scape retaining wall is recommended. However, it must be noted that there is a pipe outfall that discharges on the coastal side, also shown in Figure 4.11, which

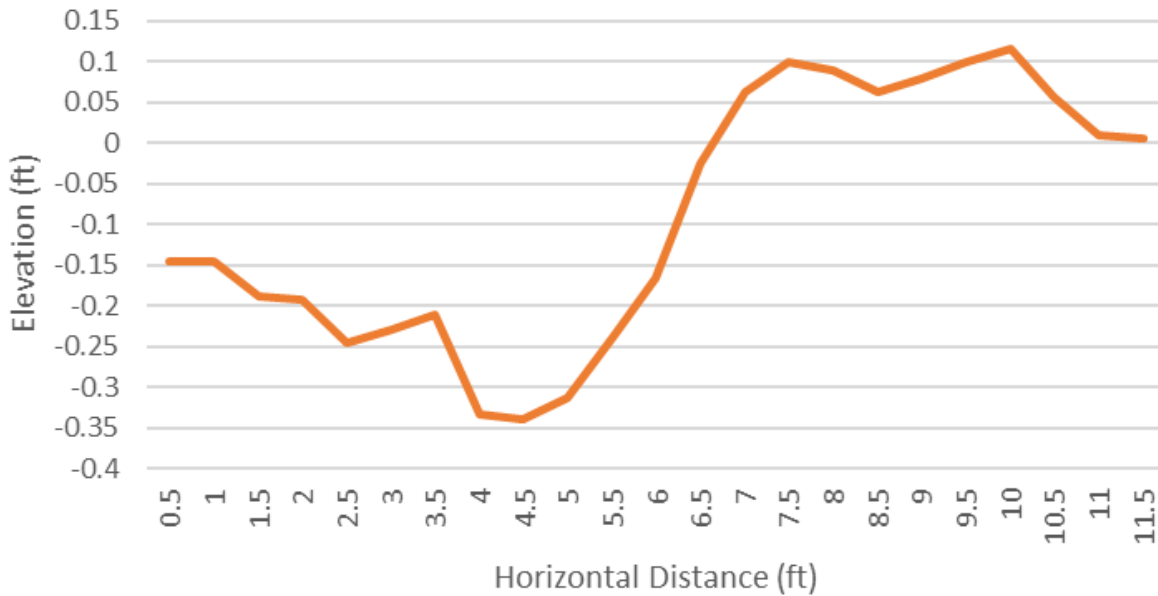
Figure 4.13: Site 1 Horizontal Profile

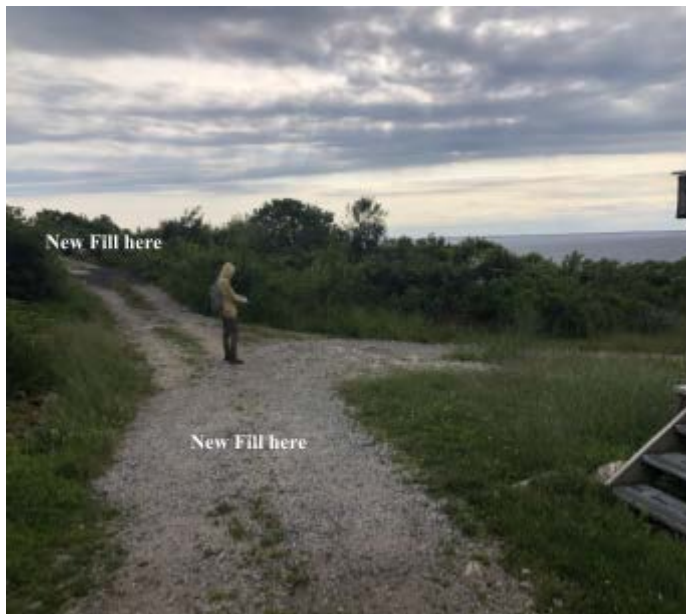
Figure 4.14: Fill on Site 2, 6/16/2022

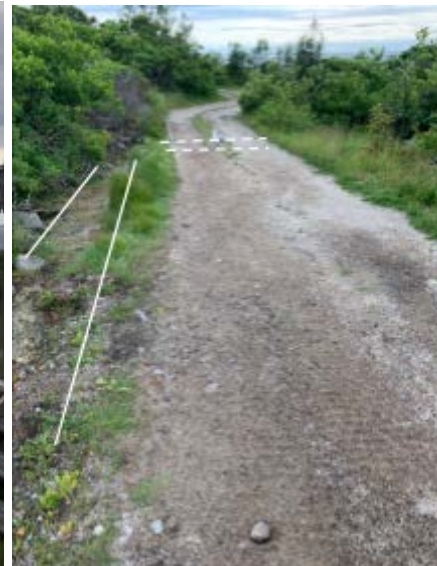
Figure 4.15: Swale and under road drainage, preventing the washing away of fines at Site 2, 6/16/2022.

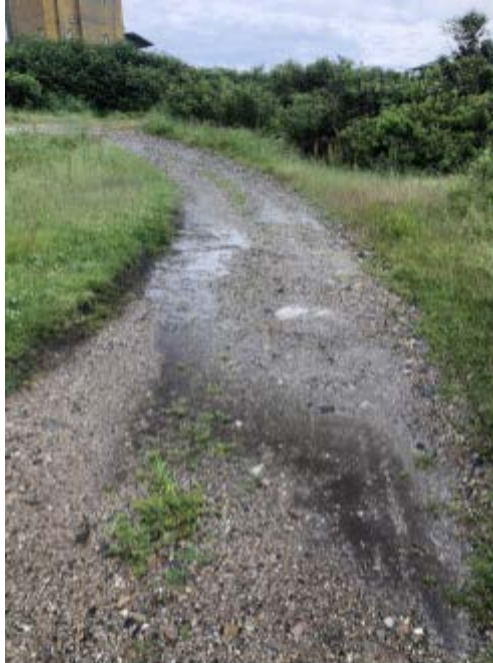
Figure 4.16: Water path during rainstorm, 6/17/2022 at Site 2.

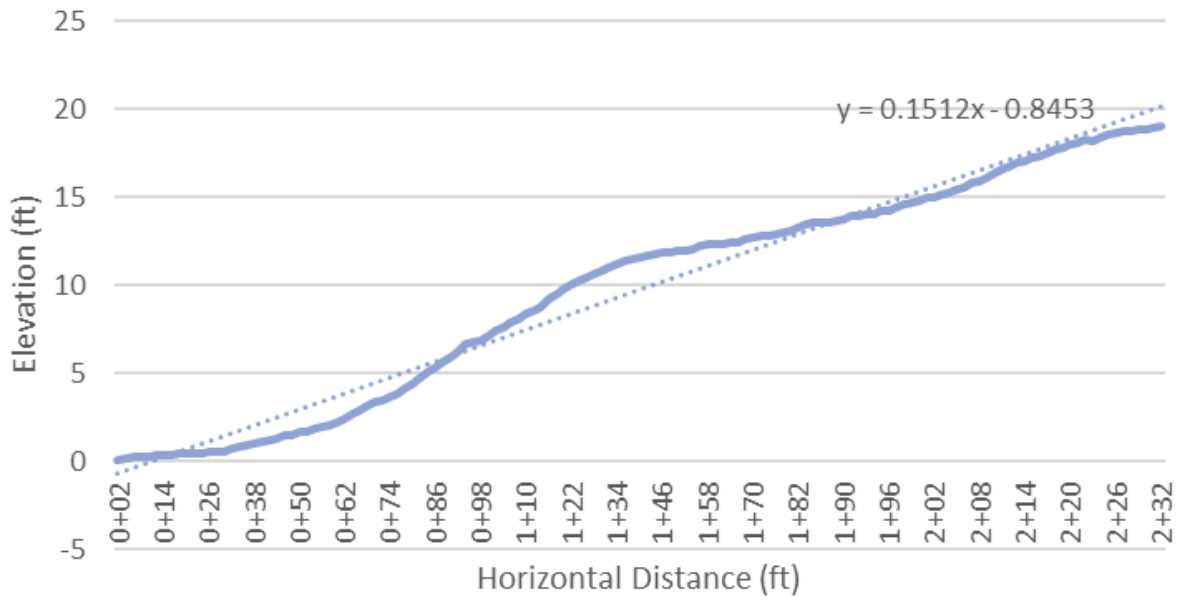
Figure 4.17: Slope Profile Site 2

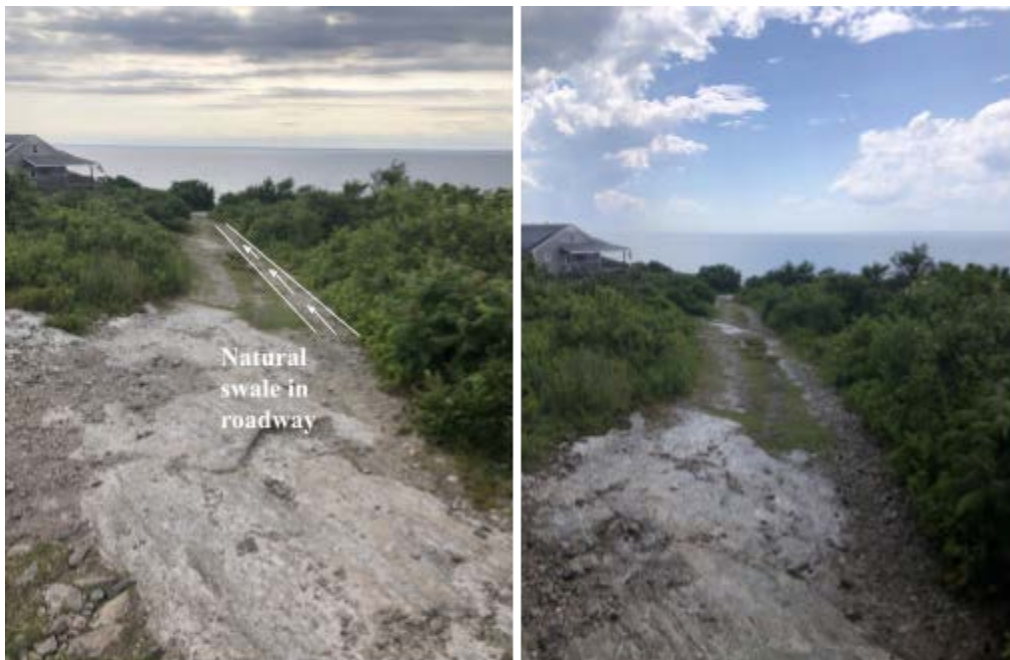
Figure 4.21: The natural swale in the roadway seen on 6/16/2022 and during the rainstorm 6/17/2022. Water flows through the roadway, deepening the swale and increasing the removal of fines.

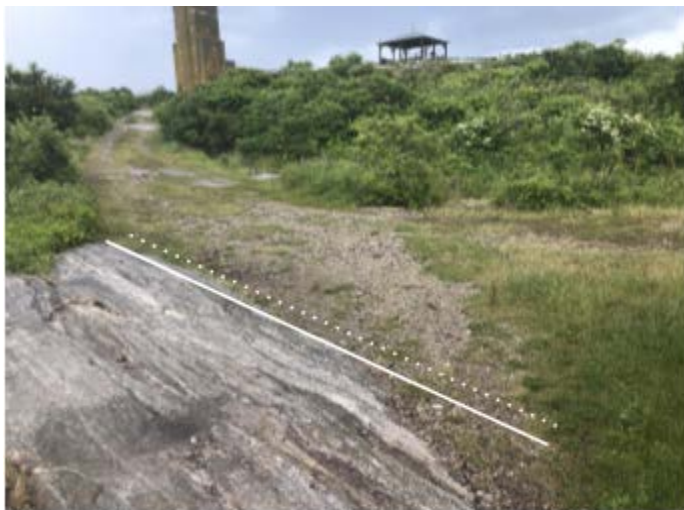
Figure 4.26: Ledge enhanced as natural level spreader; dig in front to create more of a ledge, implement riprap on side to help drainage into surrounding vegetation.

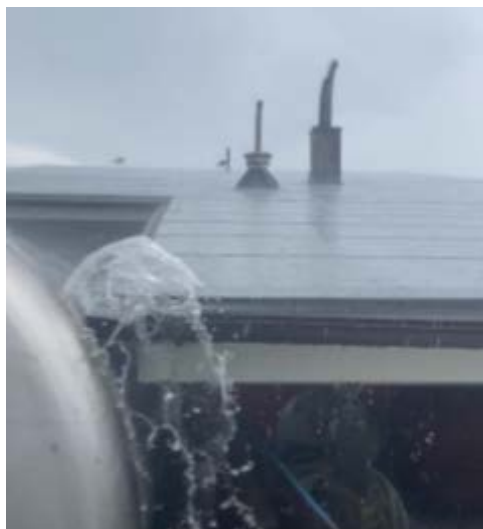
Figure 5.6: Rainwater overflow at Utilities Building gutter, leading to current rainwater storage tanks

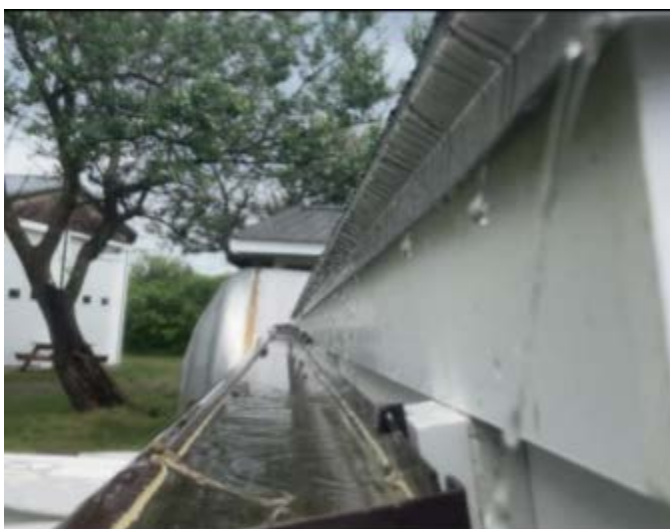
Figure 5.7: Utilities Building gutter during rainstorm; note the water dripping between the edge of the roof and the building

Interns examined the gutter performance during a rainstorm. Common complaints were that the gutters overflow during heavy rain or that much of the roof runoff shoots over the gutter. These aspects were focused on during observation of the gutter performance. Interns also remeasured the Utility Shed roof area that should be collecting rainwater by using a measuring tape. Estimations were also done using Google Maps to confirm this measurement. For additional rainwater collection, interns measured the approximate surface area of the Pole Barn, and found it to have approximately 697 ft<sup>2</sup> lateral area for rainfall. Interns looked at data available for typical rainfall for the summer months (April to August) in which the garden needed to be watered to approximate the volume of rainfall in order to properly size storage tanks. Interns also surveyed the relevant elevations for both potential options using a transit and rod. The goal of this was to quantify the elevation gain so that the necessary heights to place tanks could be determined.

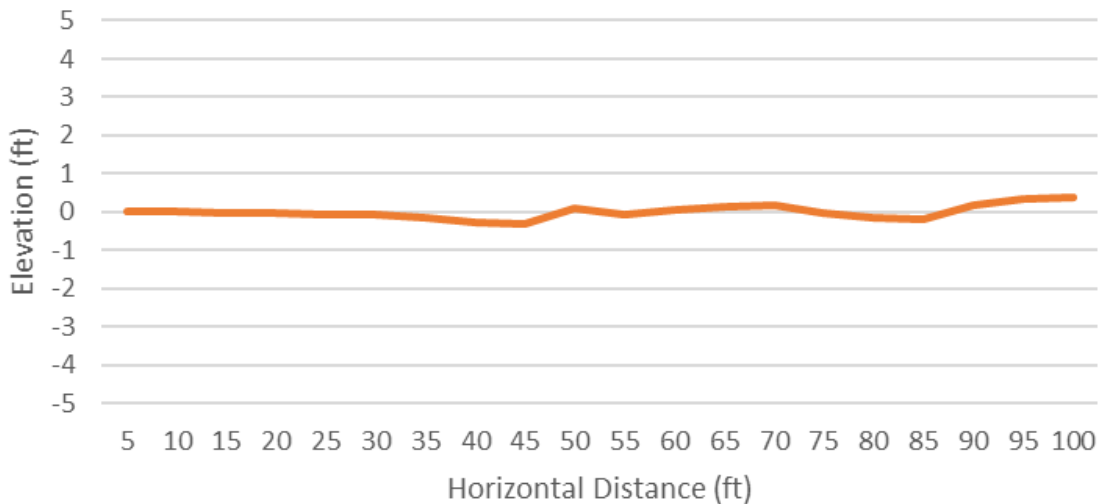
Figure 5.8: Elevation survey between current storage tanks and proposed location (Pole Barn)

The interns calculated the approximate height needed to achieve gravity feeding from the storage tanks to the garden. Using Bernoulli's equation for fluid flow, the interns found a total elevation difference of about 23 feet was required to obtain a water pressure entering the garden of about 25 psi, which was the minimum pressure required for full water circulation throughout the garden. This calculation was made assuming the lowest water level in the tank was six inches, or half a foot, as stated by previous interns in SEI Report 2015. The land elevation difference

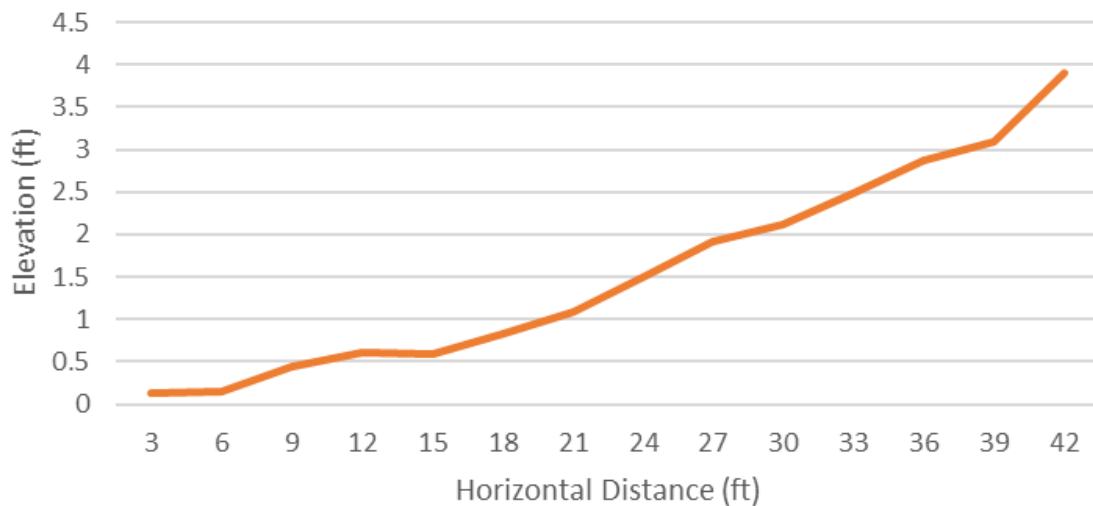
Figure 5.9: Elevation survey between irrigation control panel (Celia Thaxter Garden) and Option 2 proposed location.
